## CRYPT RESTORATION ACTIVITIES OF THE CHURCH OF SANTA AGNESE IN AGONE IN PIAZZA NAVONA – ROME

### PRELIMINARY ANALYSIS

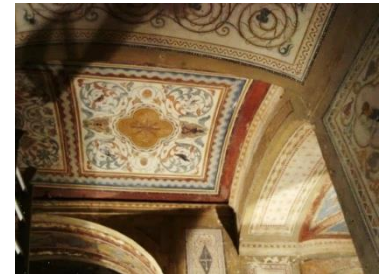
The activity for the restoration of the Crypt of Santa Agnese in Agone began in March 2017 with a historical-scientific research aimed at evaluating its state of conservation. The Crypt of St. Agnes in Agone is located in Piazza Navona, in the historic center of Rome, where the Domitian Stadium was located from the 1st century AD. The Crypt is the only surviving part of the primitive church built on one of the arches of the Stadium, right on the site of the martyrdom of the thirteen-year-old girl Agnes in Agone in 305 AD.

The Crypt is currently closed to tourists because, after its last renovation in 1893, it was subject to natural catastrophic events (flooding of the Tiber river, heavy rains, etc. ...) that have ruined the ancient frescoes on the walls and ceiling.

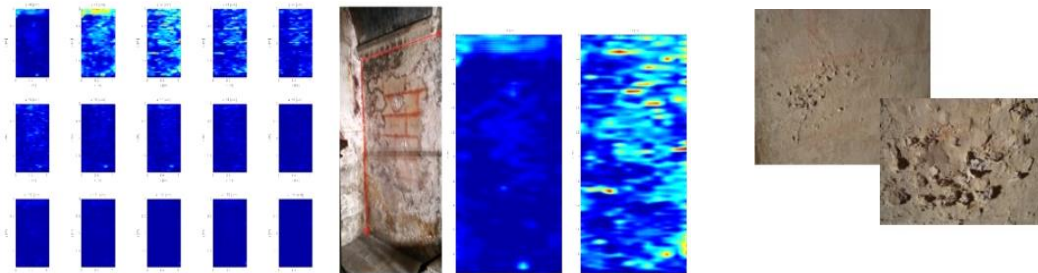
Radar analyses have been performed on different surfaces of the Crypt in order to determine the presence of water. As shown in the following images, it is evident the presence of water up to a height of 50 cm from the floor. This is due to capillary rising phenomena.

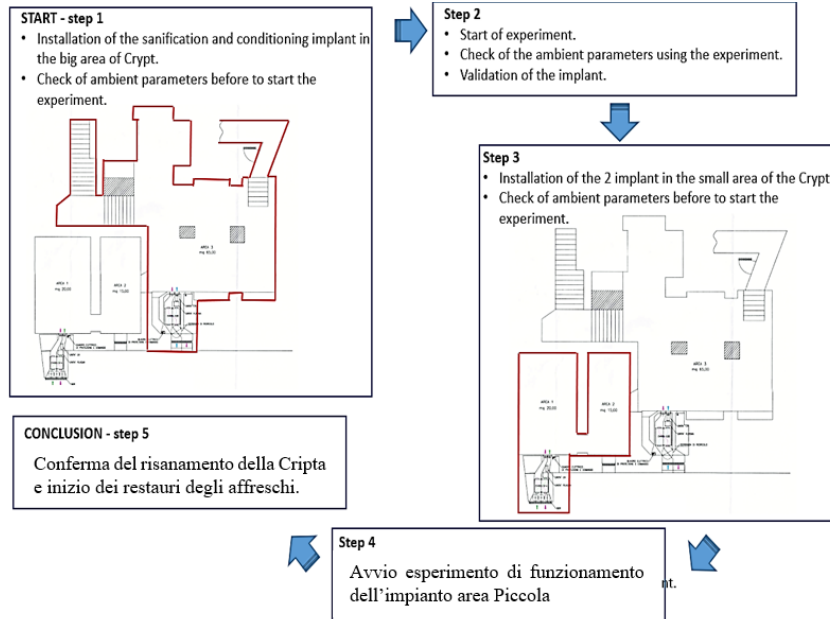
The operation of these systems aims to provide a favorable environment for the conservation of the frescoes in order to proceed to the consolidation phase and a careful restoration of the painted surfaces. The sanitation and environmental reclamation activity follows the flow reported in the following scheme:

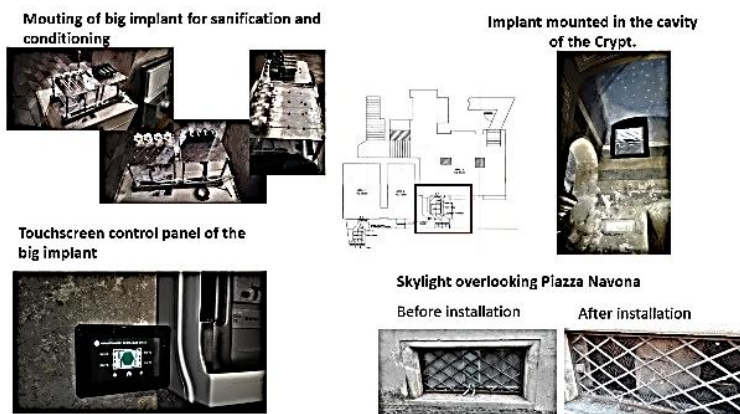
At the beginning of October 2018 in the largest environment of the Crypt the first plant was installed to start the first experiment in order to evaluate the effectiveness and efficiency of sanitation and remediation (see image on the left).

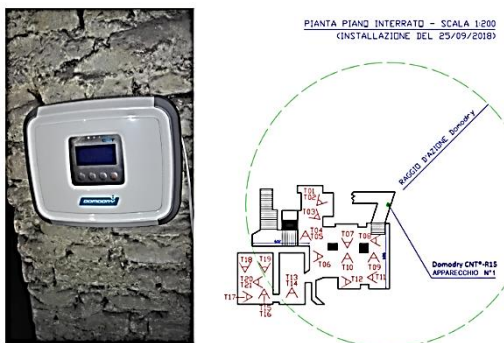
Together with this system, a system of neutralization of the electrolytic charge of the water has also been installed to avoid the effect of the capillarity of the water coming from the subsoil (see the picture on the side: salient water).

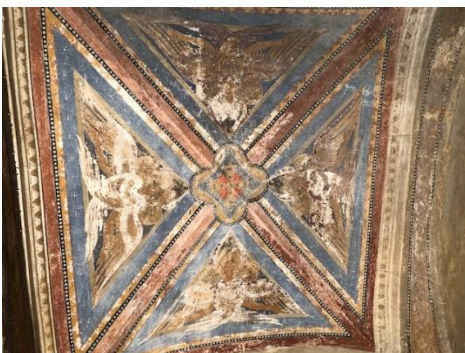
In the higher area the color was dusty and decoed; some areas show very evident color drops and widespread abrasions. During a manual typing analysis, small areas of detachment between the plaster and the masonry emerged. Medium-sized cracks were found along the attack profiles with the walls

1. Pre-consolidation of the paint film over the entire surface with a 5% acrylic resin solution (MICROACRIL) in distilled water with the aid of Japanese paper (repeated up to three times).

2. Extraction of soluble salts with repeated cycles of localized Seppiolite packs. Depth consolidation with localized injections of mortar based on natural calcium free from efflorescence salts (PLMI).

3. Consolidation of the paint film with injections of acrylic resin diluted to 3% (ACRIL) with the help of Melinex foil.
4. Dry cleaning with scalpels, brushes and vacuum cleaners.

5. Solvent cleaning with localized compresses with ammonium salts solution (ammonium carbonate) and repeated rinsing with distilled water.
6. Micro-stuccature in small cracks carried out with PLM-S.

7. Grouting with mortar without soluble salts and for grain size similar to the original mortar.
8. For the pictorial retouching and the aesthetic presentation of the product, with the D.L. it was decided to close the images where there were clear references to follow, using fixed and consolidated watercolors; the grouts were always chromatically accompanied with watercolors.

9. Final protection for nebulization of Microacril at 1%.

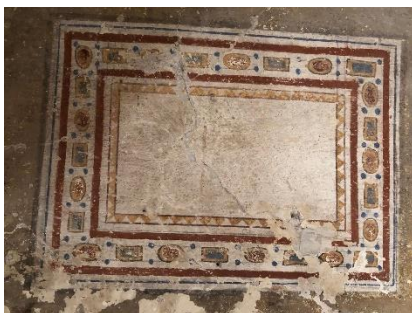
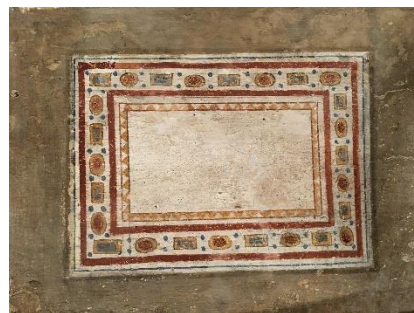
Pictorial portion above the pillar before and after the restoration.

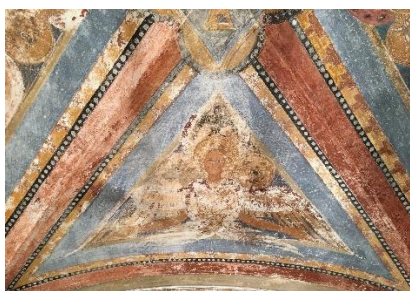
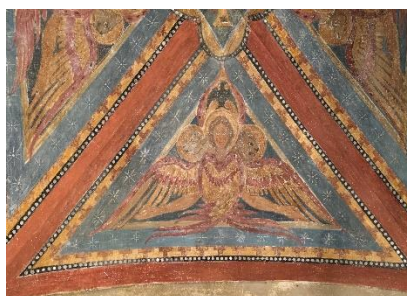
Detail of a sail before and after the restoration.

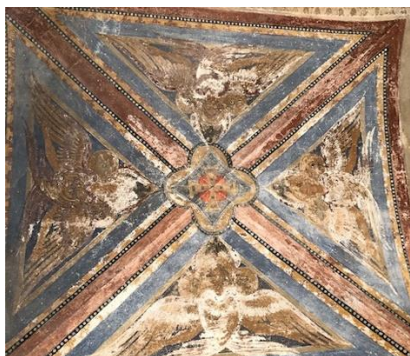
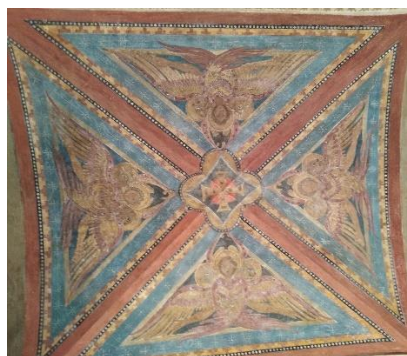
Complete vault before and after restoration

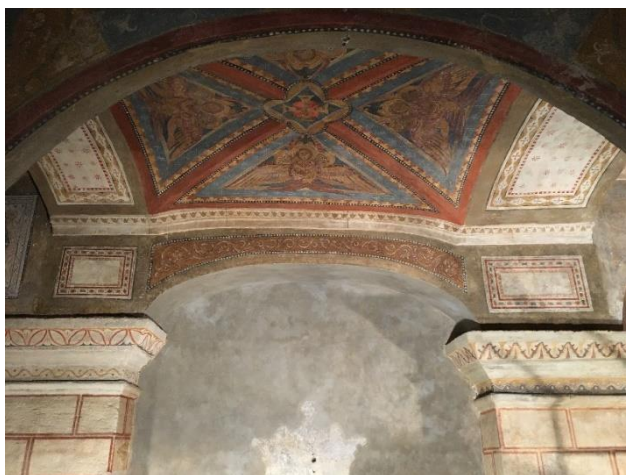
Vault after the restoration.

The inspection carried out one month after the end of the work, confirmed that the restoration work has not undergone any alterations; it will be monitored at regular intervals during the period that will involve the higher temperatures of both hot and cold.
